RAILWAY INVESTIGATION REPORT
R04T0008

MAIN-TRACK DERAILMENT

CANADIAN PACIFIC RAILWAY
TRAIN NO. 239-13
MILE 178.20, BELLEVILLE SUBDIVISION
WHITBY, ONTARIO
14 JANUARY 2004

Report Number R04T0008

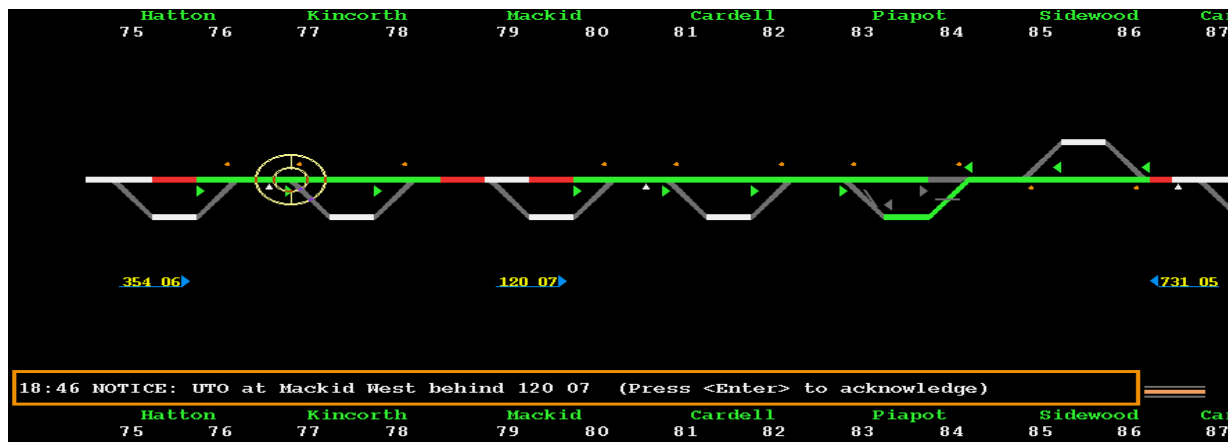
When a track occupancy occurs behind a tagged train, the following alert will appear on the RTCs workstation:

When this alert appears on the RTC workstation, the keyboard will lock up preventing any further keystrokes until the ENTER button is pressed.
